Repair monitors: Philips CM 8833

Original by: Bas Kornalijnslijper Translated by: Bart Hamer

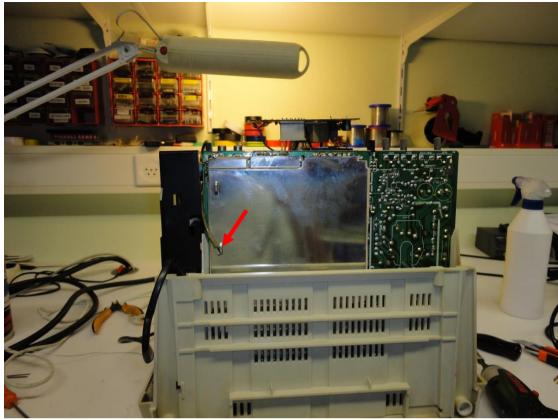
Unsolder the ground wire at the red arrow.

- Unsolder the ground wire from the power supply board to the base board.
- Remove the power supply board.
- Remove the switch.
- Fit the new switch.

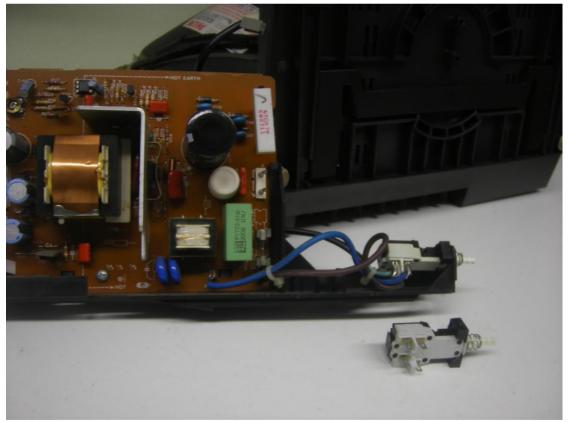
Defective switch connected to the power supply PCB and a loose new switch.

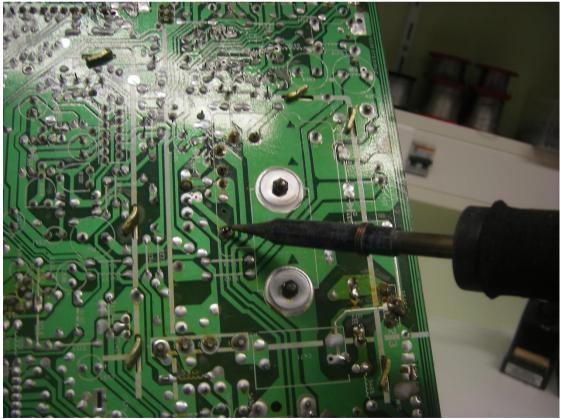
Soldering using proper tools.

Another problem with this monitor is that after prolonged use, a prolonged standstill, a lot of changing cables or being transported a lot, various parts become loose. This will result in the monitor becoming unstable. Print spot fractures are often invisible to the naked eye, so it is wise to re-solder several parts. In order to be able to reach everything, the main board has to be removed. The metal shielding plate also has to be removed. Also desolder the two auxiliary boards (TTL-Interface and Stereo Amplifier), on which various components are located. The connections of the auxiliary boards to the base board also often show print spot fractures. The solution to this is to re-solder several parts:

- T101 (Transformer on power supply board)
- T402 (High voltage transformer)
- Scart connector
- Audio/Video connectors
- TTL connector
- IC302
- IC502
- IC401
- IC402
- IC501
- IC251 (TTL-Interface)
- IC252 (TTL-Interface)
- IC801 (Stereo Amplifier)
- IC803 (Stereo Amplifier)
- IC804 (Stereo Amplifier)

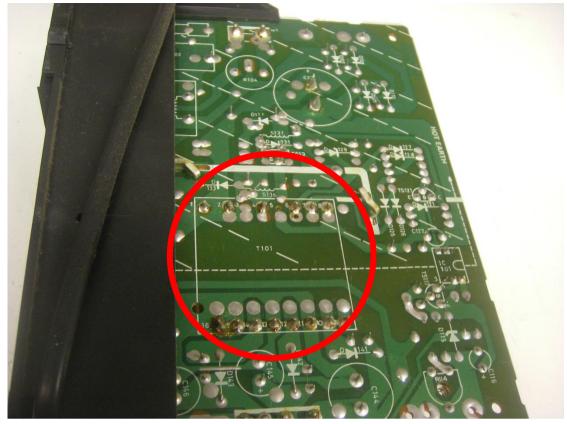
The power supply PCB.

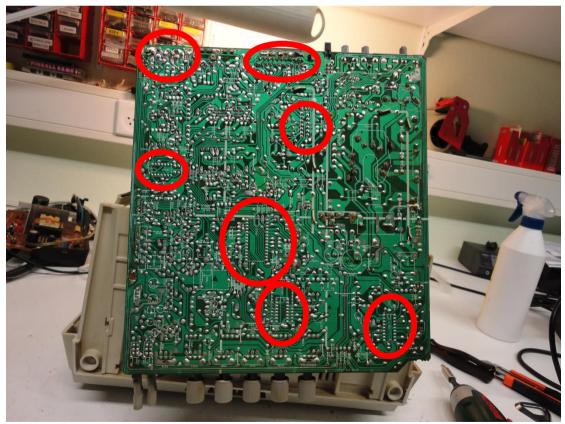
The marked parts are the most susceptible to print spot fractures.

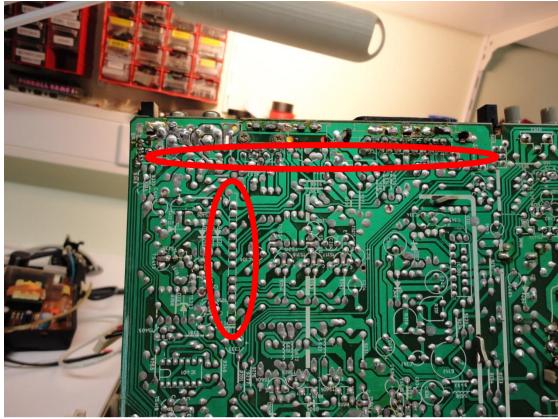
The connections to the two auxiliary boards are marked.

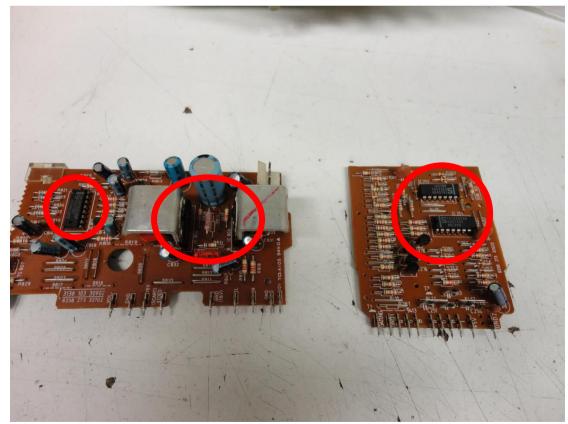
The two auxiliary boards: Stereo Amplifier and TTL-Interface. The marked parts are the most susceptible to print spot fractures.

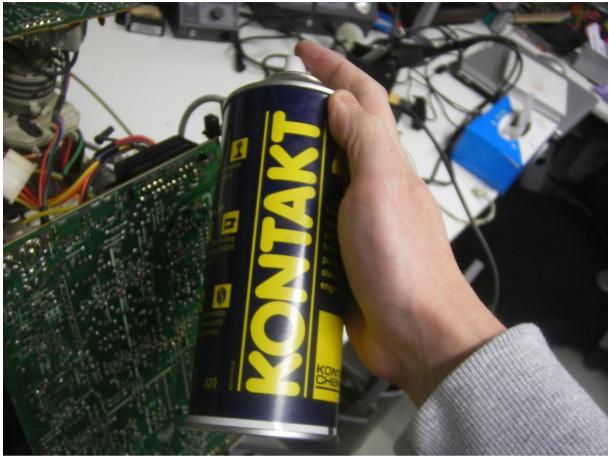
Inject contact spray into all potentiometers.

Use contact spray to properly spray all potentiometers (regulators) on the front and rear, so that oxidation disappears. Wipe off any excess contact spray with a cloth.
