Repairing a Philips SBC 3810 mouse with a used joystick cable

(Also applies to Panasonic FS-JM1 & Sony MOS-1)

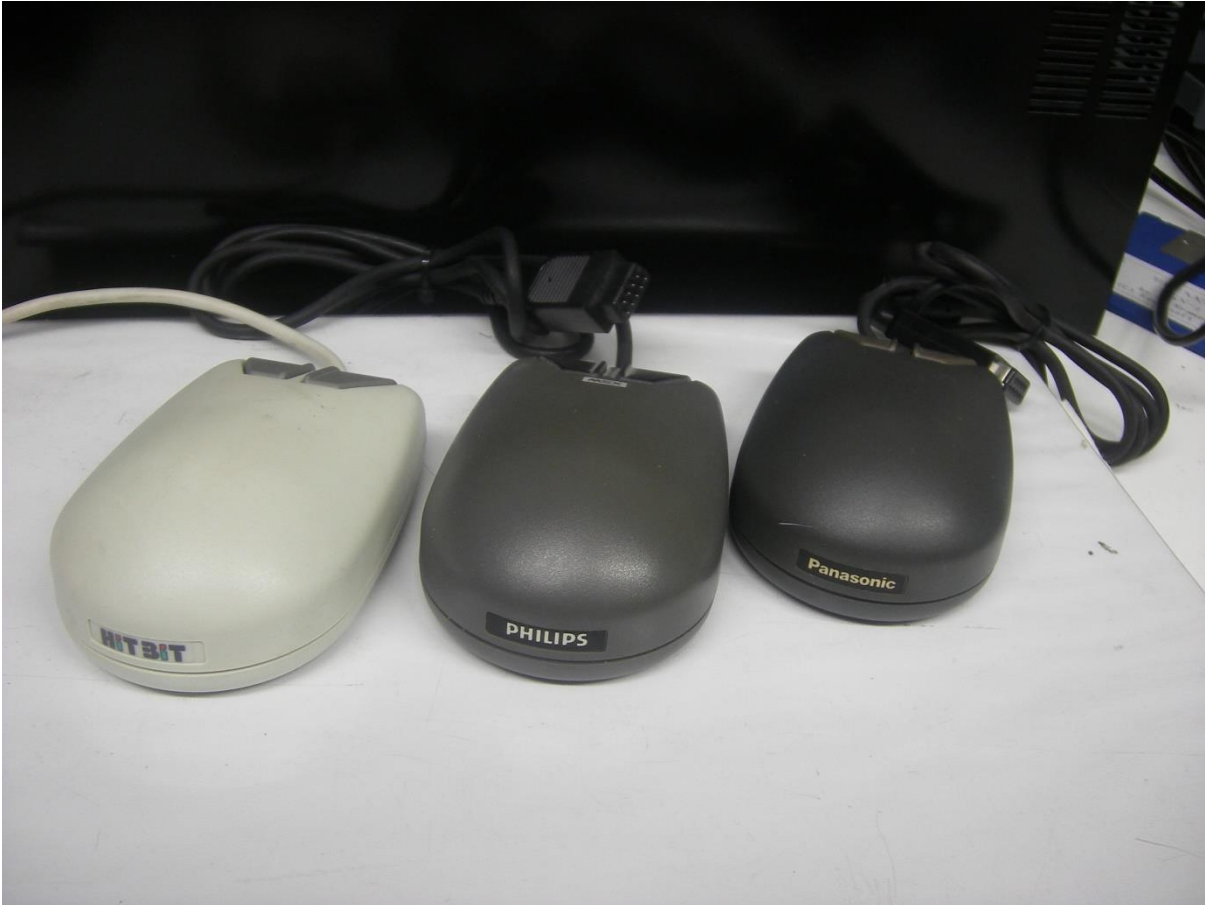
Sony MOS-1, Philips SBC 3810, Panasonic FS-JM1.

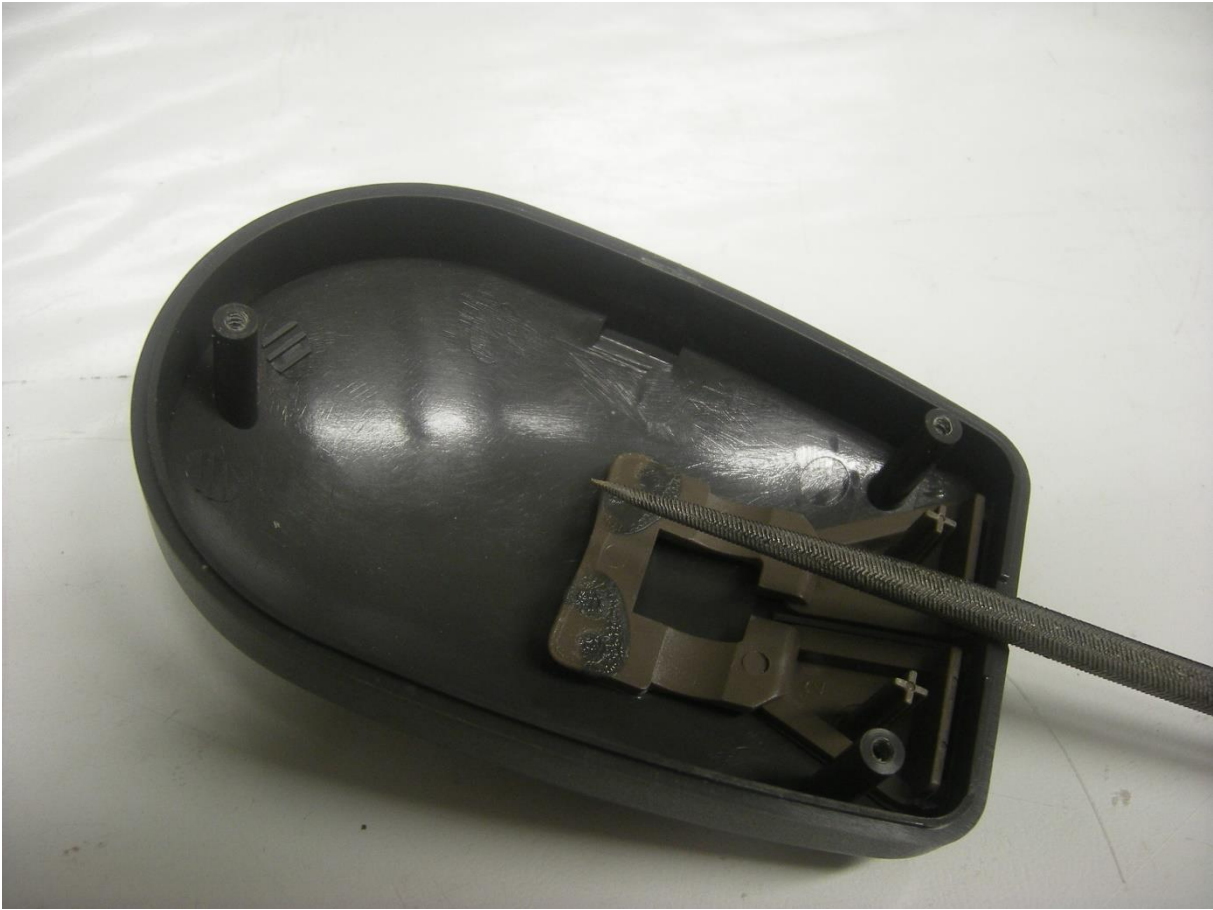
Adjusting the case for the "new" cable.

- Unscrew the mouse.
- The cable can be easily detached, because it is connected with a connector.
- Remove the PCB.
- The part of the “new” cable that enters the mouse’s case may be a bit too big. This can be solved by adjusting the case.
- Solder the wires of the “new” cable to the pins of the connector or to the places on the PCB where they used to be. Solder them according to the diagram below. The yellow wire of the “new” cable is pin 1 (+5V DC).
